Benedict House Access Project (BHAP)

EDSGN 100. 13

Task: Design an access path to the Benedict house, in order to provide a safe pathway for easy access. Specifically we are designing a parking lot and a pathway to the Benedict House.

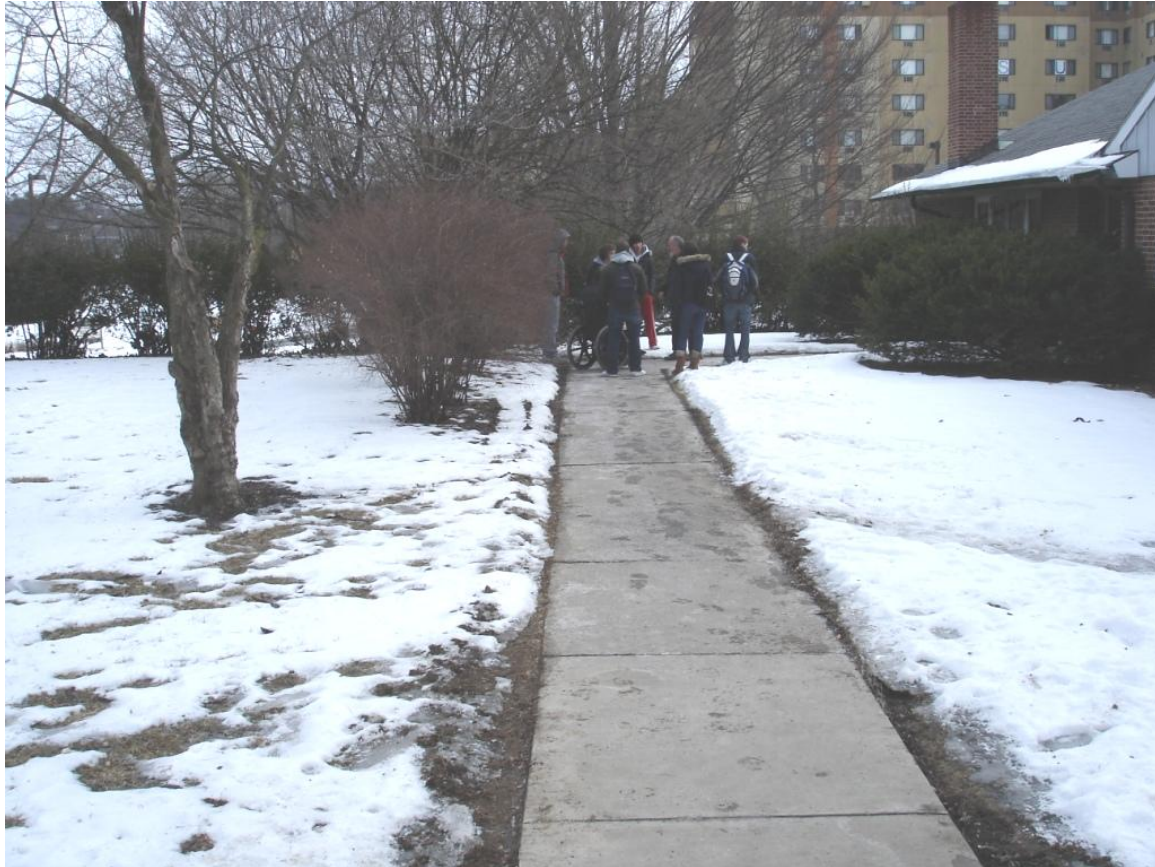
Figure 2. Benedict House is on the right, and the suggested parking lot will be to the left of this sidewalk.

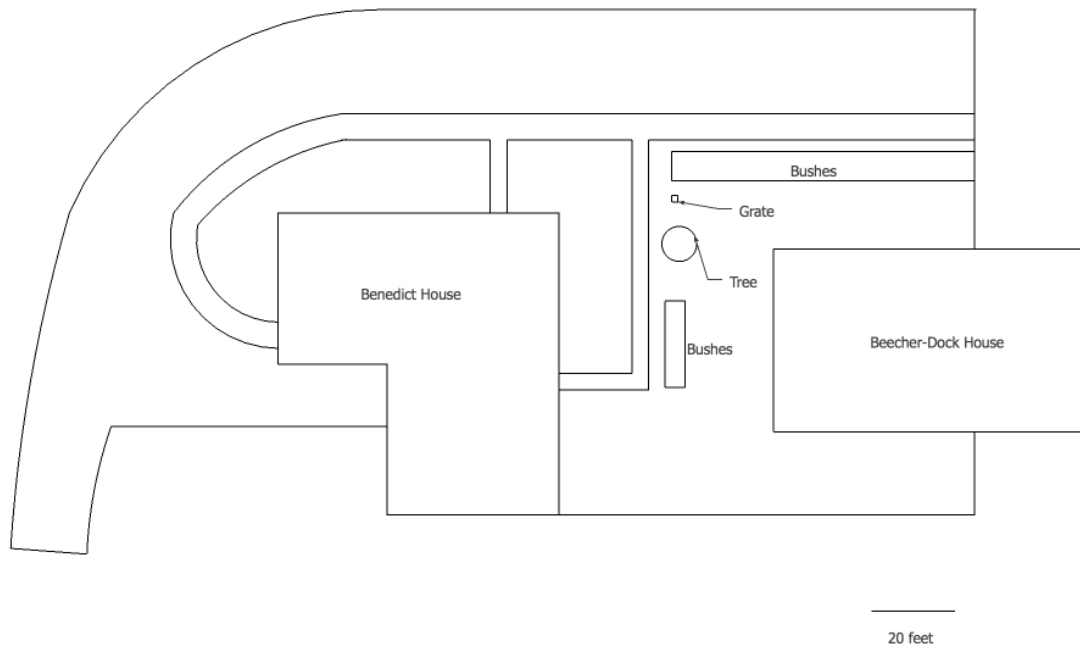
This is the basic outline of the property

Figure 3. Basic outline of the Benedict House and the surrounding property

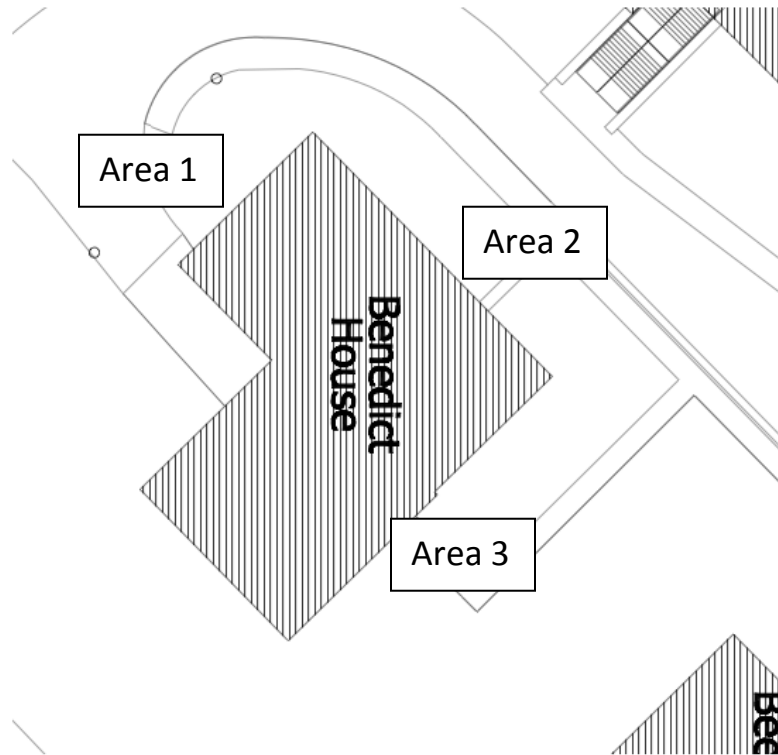
Figure 5. This figure shows the areas our group considered for the final solution

Our group decided that the location of the parking lot must be as close to an existing entryway to the building as possible. As such, we identified three possible areas for placing the handicap accessible parking spaces, since each would be near an entrance to the building. Our group ruled out area 1 since the corresponding entryway is the least handicap accessible. In order to make the entryway for area 1 more accessible, there would need to be a ramp, which would take away from the space necessary for designated handicap parking spaces. Also this entrance is not very accessible because of the stairs just inside the door. Our group ruled out area 2 since the amount of space between the building and the road was significantly less than what is necessary for a handicap accessible parking space and a designated unloading zone. There is a large tree where the space would be placed, and we are not prepared to remove it. We therefore chose area 3 since it would provide the best compromise between cost effectiveness and access. Area 3 also has its limitations simply because of the way that the Benedict House is constructed. For instance, the entrance corresponding to area 3 requires a ramp for full access (although the ramp would take up less space than that in area 1). Also, a parking lot in area 3 would require removal of bushes and some trees, and would take away from green space more significantly than areas 1 and 2.

In conclusion to our report and cost analysis, we found the cheapest and best site was area 3 from figure 5. This is on the east side of the Benedict House. Despite this being the cheapest, the job would still cost around \$15,000 to accomplish. We are not sure we would recommend Penn State going this route because of the cost. Our final judgment depends upon to what extent Penn State wants to utilize the Benedict House and its surrounding area. If they plan on using this area for years to come, then this will be a great investment. If they plan on tearing it down and moving somewhere else, this will be an expensive investment for the minimal use they would get out of the Benedict House. Also, perhaps Penn State has its' own crew and concrete, which would ultimately decrease the cost we currently have estimated.

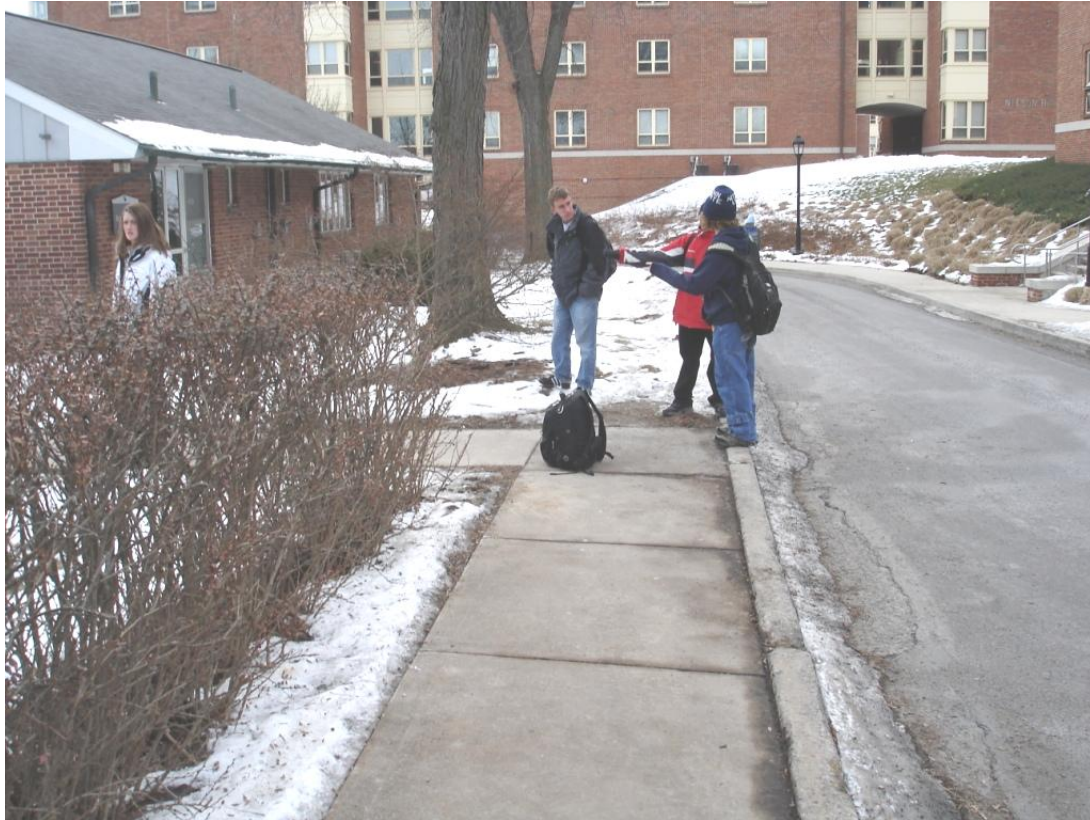
Figure 6. The entrance to the proposed parking lot will go over this sidewalk. Sidewalk and bushes must be removed.

Abstract: Access to the Benedict House currently does not meet federal and Penn State guidelines. The design solution involves building a parking lot in the lawn between the Benedict House and the building to the east, with two van accessible parking spaces and a 8-foot loading and unloading zone between them. This maximizes the parking area while minimizing the green space taken. The new parking lot will be located to the leftside of the sidewalk in figure 2. The closest tree and red bush will be removed, but green space will be maintained by planting new trees and bushes. Figure 6 shows additional bushes that must be removed.

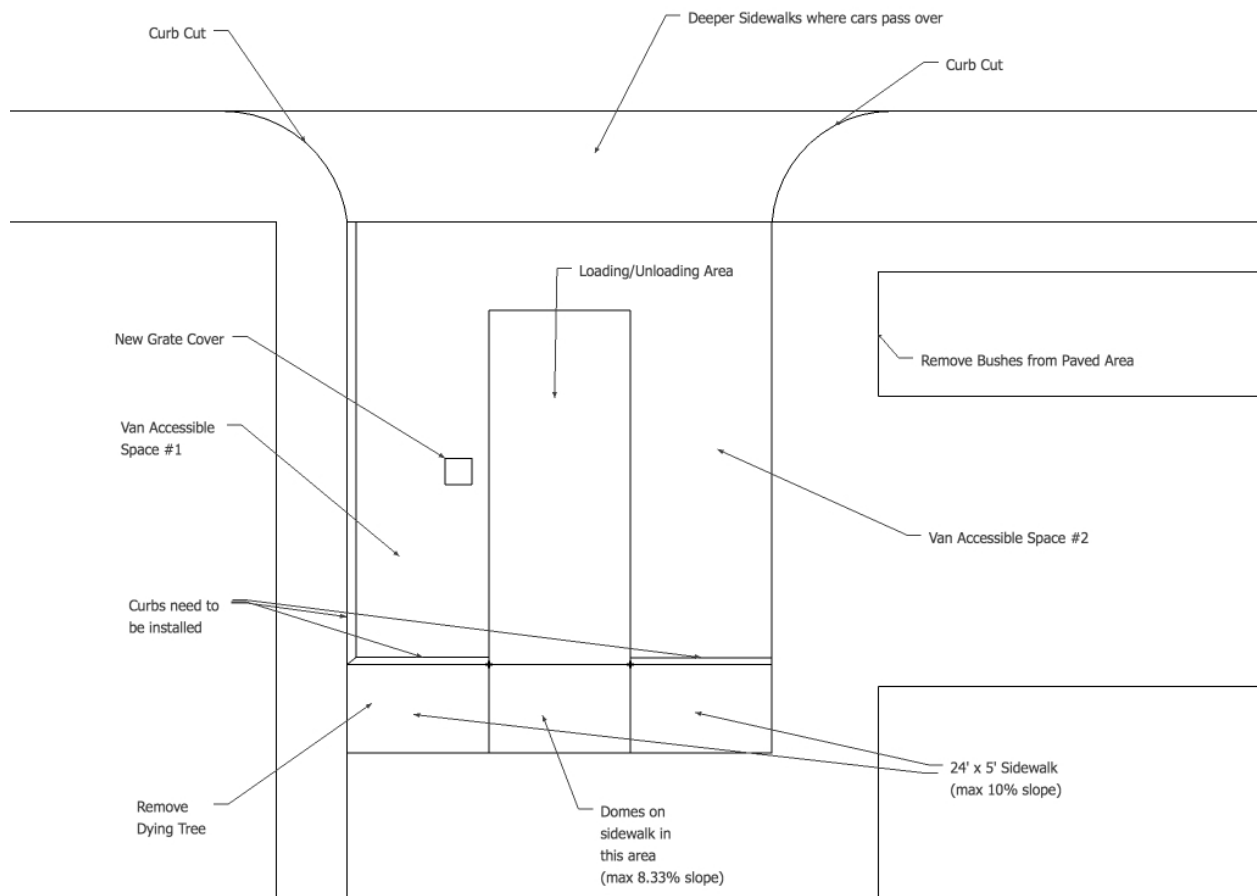
Figure 7. CAD of proposed plan

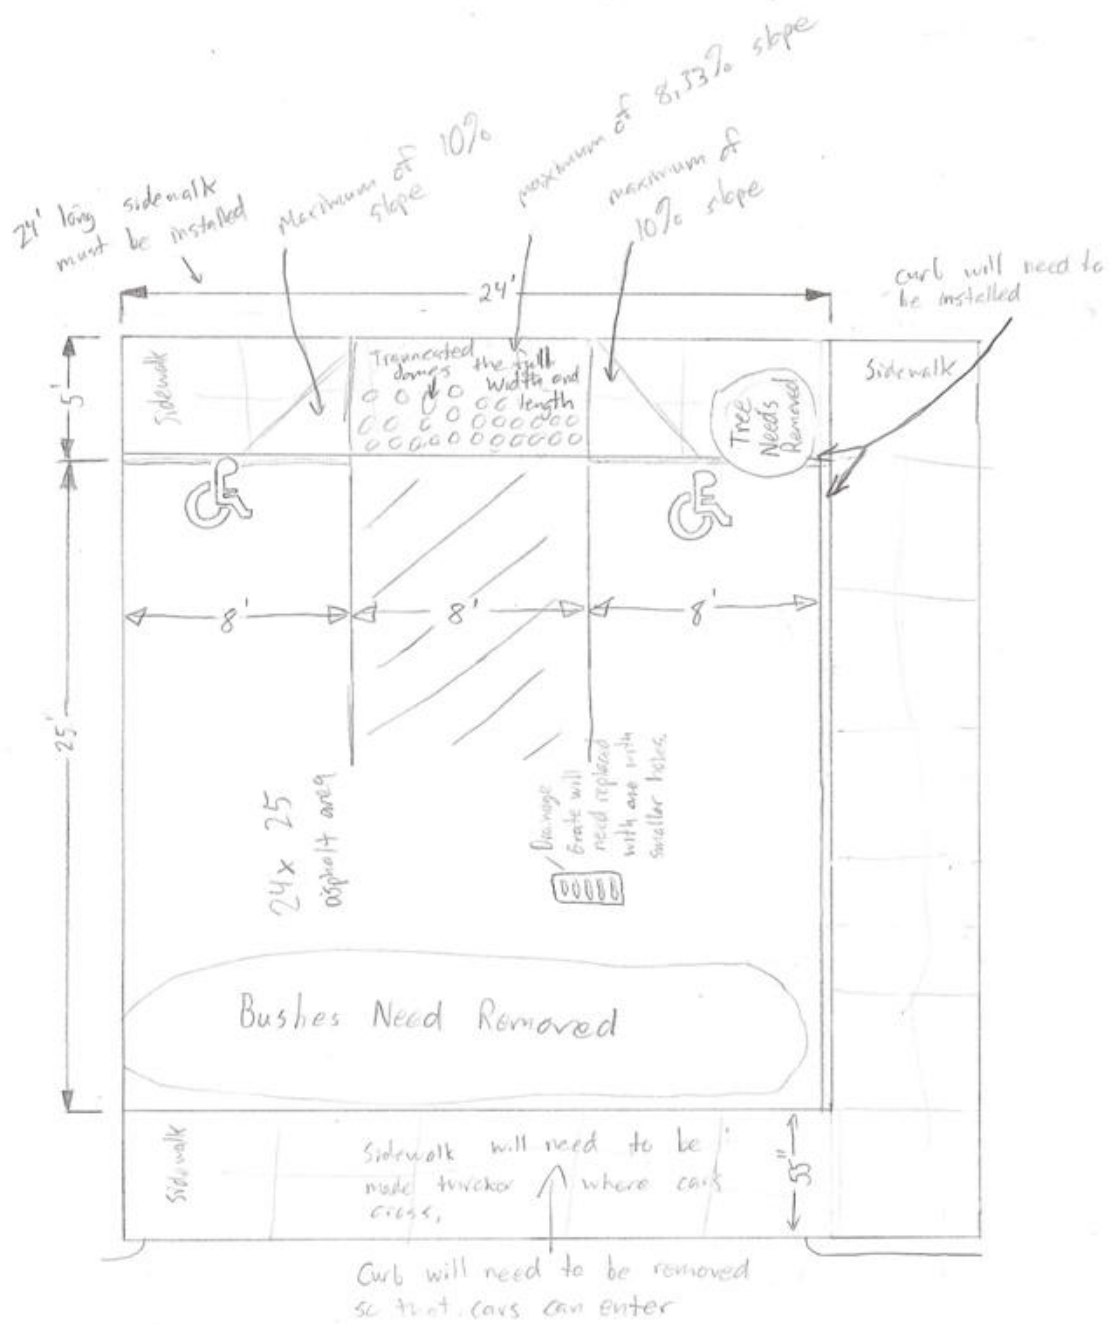
Figure 8. Plans of what must be accomplished
