E. Design 100.012

Final Report

Product: TODA

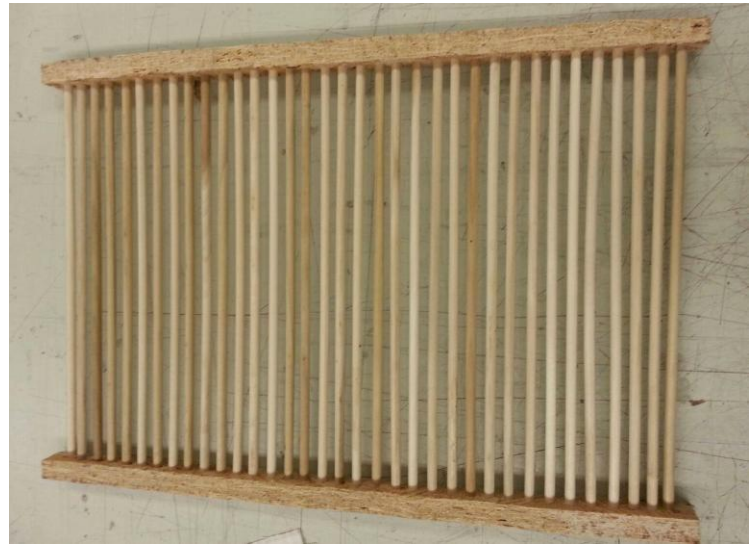
Figure 1

While the solar food tray prototype #1 proved to be easy to clean, reasonably priced and made of food grade materials, it has failed to be durable. As seen in the "AFTER" picture in Table 1 below, the wooden frame of the tray broke. In order to ensure that prototype #2 does not experience the same problem, the tray must be made of stronger materials. Therefore, the structural support of the prototype #2 is made of thick wooden planks (as seen in Figure 1) instead of the cardboard. The use

of harder wood provided more strength to the product.

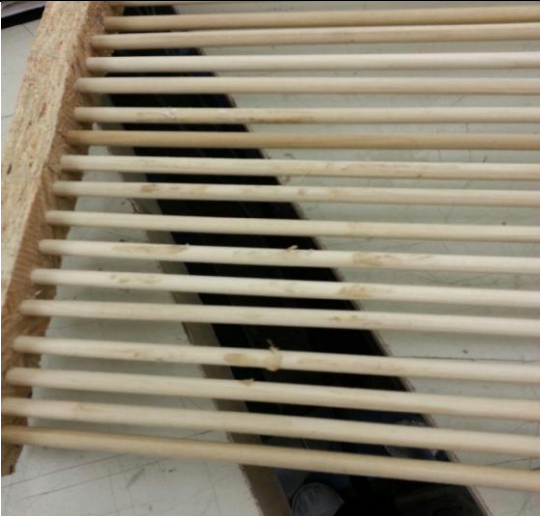
<p>Figure 2: Before Cleaning</p></div>

Design Constraint (C)	Test	Result	Conclusion	Picture
Durable	Drop the tray 20 times from the height of 5 feet and look for damages	The tray was able to withstand the 20 drops	PASS	N/A
Easy to Clean	Clean the tray with a damped cloth for a minute	The tray was successfully cleaned	PASS: the cloth to remove the entire residue within a minute.	<div>

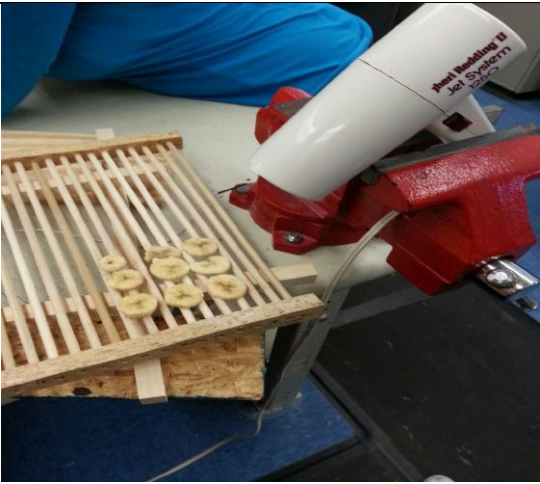
In Table 2 above, Figure 3 displays the tray when undergoing the speed drying test, in which a small number of banana slices were partially dried under a hair dryer.
