The Wire Dryer - Final Report

Group 7 - Mitch Tabor, Chad Fennelly, Hussain Al-jama, Nick Caggiano

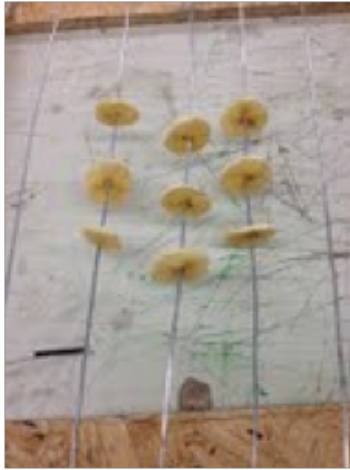
Figure 1: Banana slices on tray post-drying

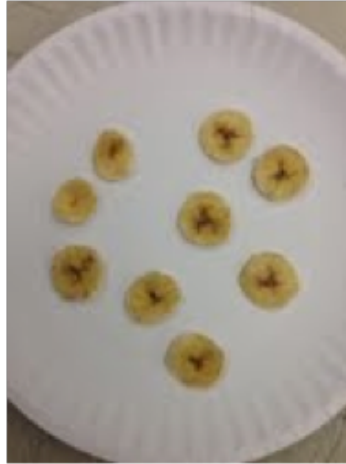
Figure 2: Banana slices removed from tray post-drying

After the 15 minutes was completed, the banana slices appeared as pictured in Figure 2; their edges were beginning to dry, but their centers were still wet. This was a stark contrast to the dried slices from Prototype #1 (Figure 8). The quantitative results confirmed this, as the rapid-drying test only reduced the water content in the banana slices by roughly 23% (see Table 1). For only 15 minutes of drying, the 23% reduction was still a significant reduction. However, it would be unfair to compare the results of the rapid-drying test directly to the results of the oven-dry test done on Prototype #1—they are two very different drying techniques. In the oven, only convection causes movement of air, whereas the hair dryer pushes high-velocity air at the fruit. Thus, the hair dryer will dry the bananas at a higher rate. Using a linear estimation of drying rate, the hair dryer method reduced the water content of the fruit at a rate of about 92% per hour, while the oven drying method managed a rate of about 12% per hour.

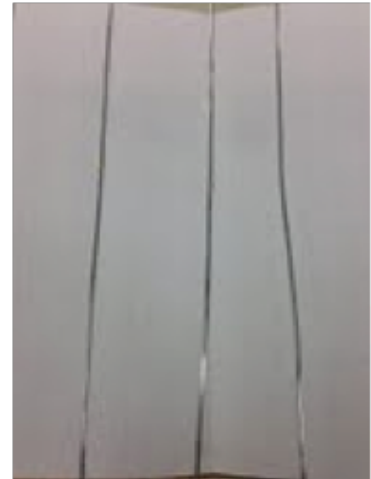
Figure 3: Banana residue after wash test

The same wash test was performed on Prototype #2 as was performed on Prototype #1, and our observations seem to show much better results for Prototype #2. In Figure 3, no banana residue is visible after washing, whereas Figure 11 and Figure 12 depict banana residue spots even after washing. However, the observations may be misleading, as Prototype #2 did not dry the bananas as much. The banana residue did not harden and stick to the tray. After the rapid-drying test the bananas slid off with ease because their centers were still wet. Therefore, not

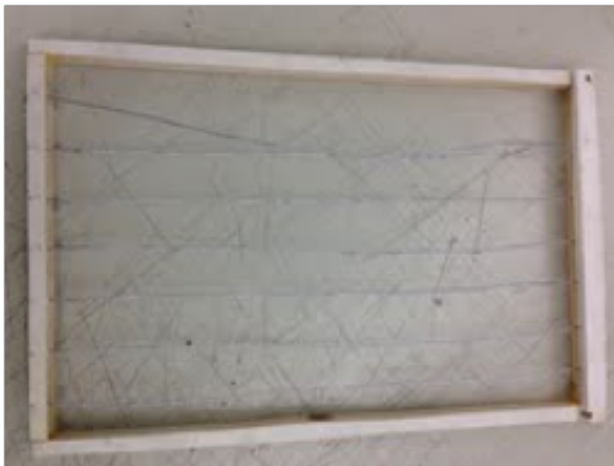
Figure 4: Top of tray after long side drop test

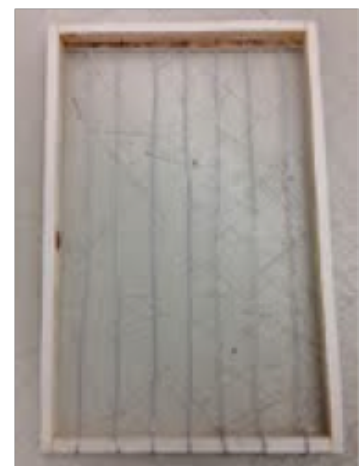
Figure 5: Bottom of tray after horizontal drop test

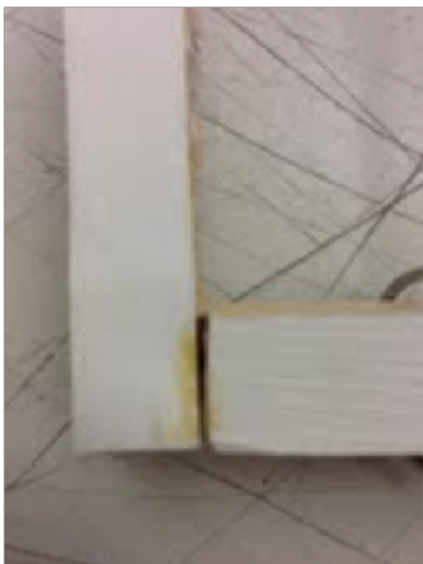
Figure 6: Corner of tray after corner drop test (most severe damage shown)

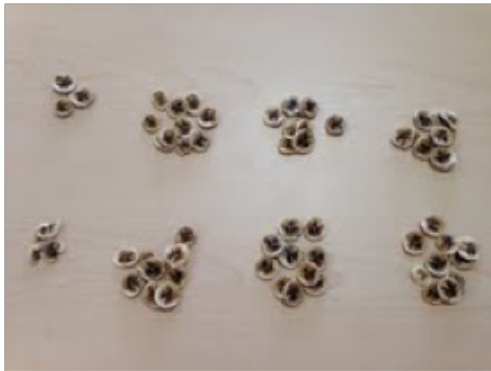
Figure 7: Dried banana slices (68 total)

The main difference in the testing of Prototype #2 as compared to that of Prototype #1 was in the way the Drying Effectiveness test was carried out (see Table 1). For Prototype #1, the tray was loaded with two banana's worth of slices—we counted 68 (see Figure 7)—and was placed in Ms. Kisenwether's home oven for 6 hours. The weight of the banana slices was determined before and after drying, and the percent reduction in water content (assuming that all loss of mass was water) was calculated to be roughly 71%, as shown in Table 1. In contrast, Prototype #2 was tested with a rapid-drying method, as there was not enough time to complete another full drying cycle in the oven. For the rapid-drying test, nine banana slices were arranged on the tray as shown in Figure 1. A thermocouple was placed near the center of the banana formation so that a temperature reading could be taken. A 1250-watt home hair dryer set to "High" was aimed at the center of the formation, and the distance from the hair dryer to the thermocouple was manipulated by moving the hair dryer. The goal was to keep the thermocouple reading as close to 60 degrees Celsius for the duration of the 15-minute test.

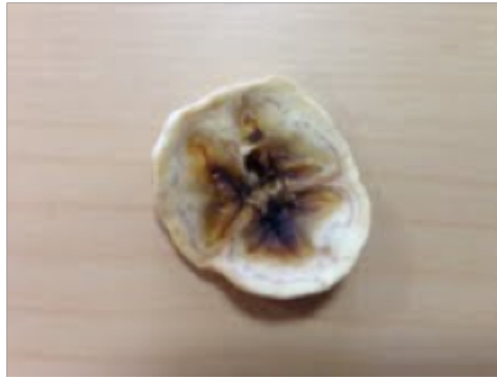
Figure 8: Dried banana slices close-up

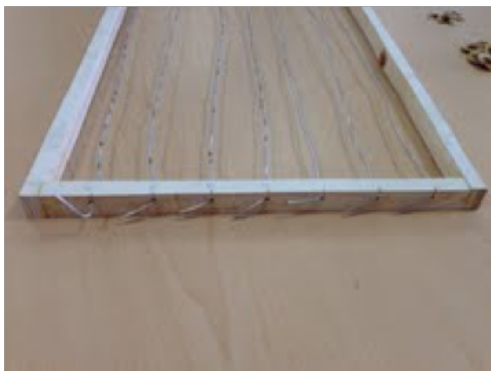
Figure 9: Tray side view (fixed wire ends)

Another major change in Prototype #2 was in its construction. The loading and unloading mechanism was redesigned, and this modification is the primary feature of Prototype #2. It features wires that are fixed at one end (similar to Prototype #1—Figure 9), but the other ends are straight instead of the curled ends pictured in Figure 10. Not having curled ends makes it easier and less time-consuming to load the banana slices; with no wire to uncurl, the user simply rotates the retaining bar (pictured on the right of Figure 4), lifts up a wire, and slides the slice on the wire. When all the wires are loaded, the retaining bar is rotated back to its original position, where it snaps into place. Additional modifications found in Prototype #2 include additional nails in the joints to increase the joint durability during drop tests. In our drop tests, Prototype #2 performed similarly to Prototype #1. Joint separation was still evident (see Figure 6, Figure 13). Additionally, since the wire ends are no longer curled around the side, there was potential for them to be dislodged as a result of an impact. As depicted in Figure 4, some of the wires were dislodged after the long side drop test, but Figure 5 shows that all of the wires remained in place in the horizontal drop test. We are not concerned with the wires becoming dislodged—a shake test was performed (see Table 1 for details), and no wires were dislodged. Even if a wire were to come out of place, the fruit would not likely fall off, and the wires are easy to put back into place.

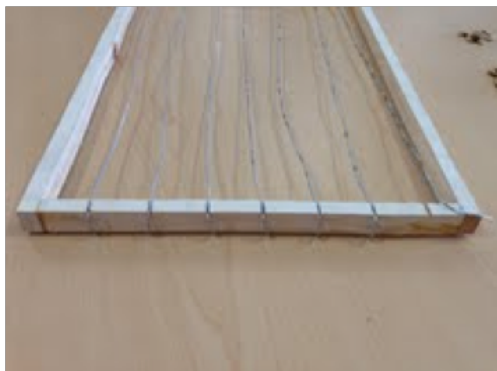
Figure 10: Tray side view (curled wire ends)

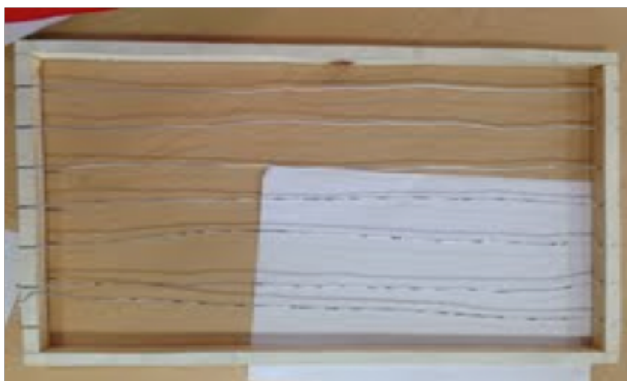
Figure 11: Tray top view prior to wash test. Black spots on wire are banana residue.

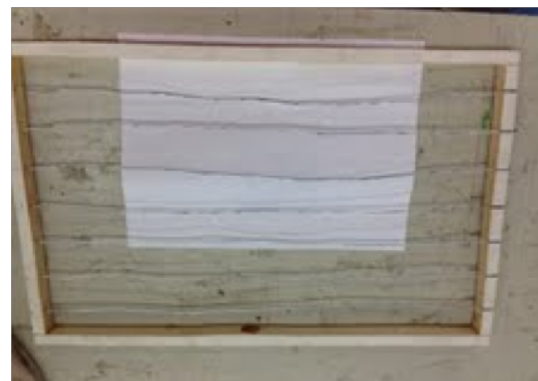
Figure 12: Top view after wash test. Black residue spots still exist, but there are fewer.

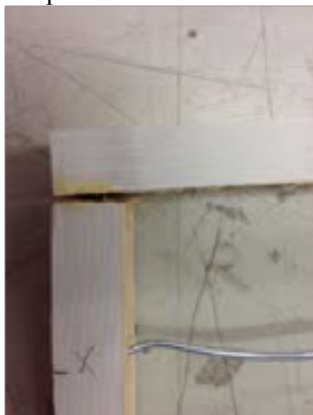
Figure 13: Corner of tray after corner drop test.
