EDSGN 100, Section 20, Group 5, The Green Elephants  
Spring 2013

Design for Emerging Markets: Kenyan Rainwater Gutter System

The Kenyan Color Gutter

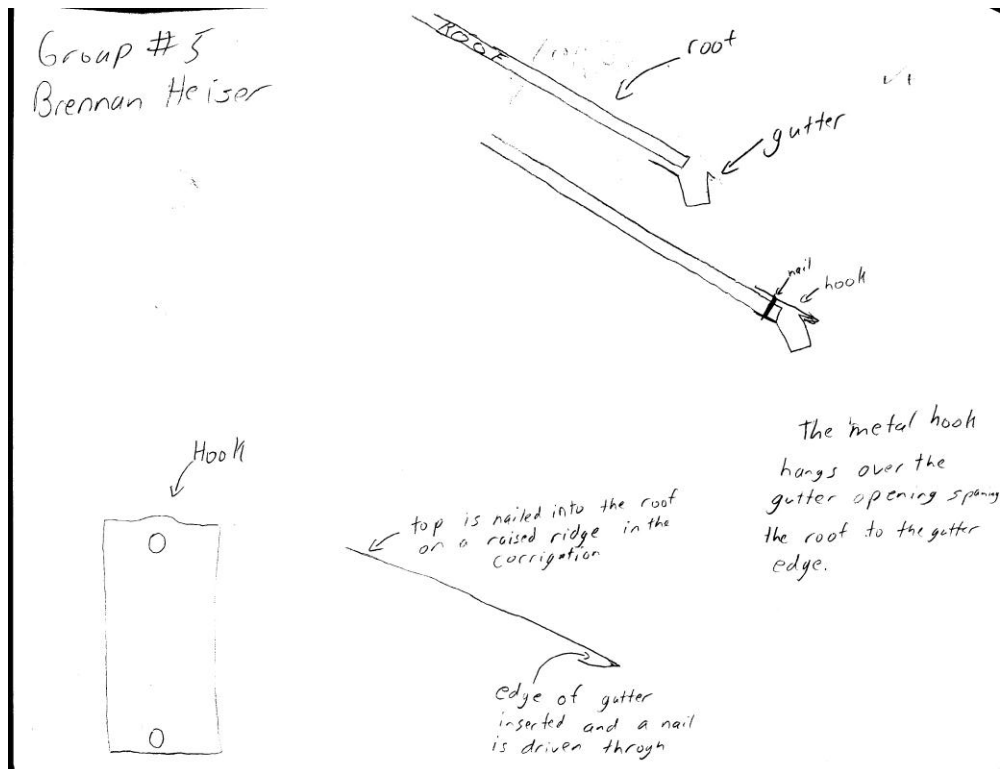
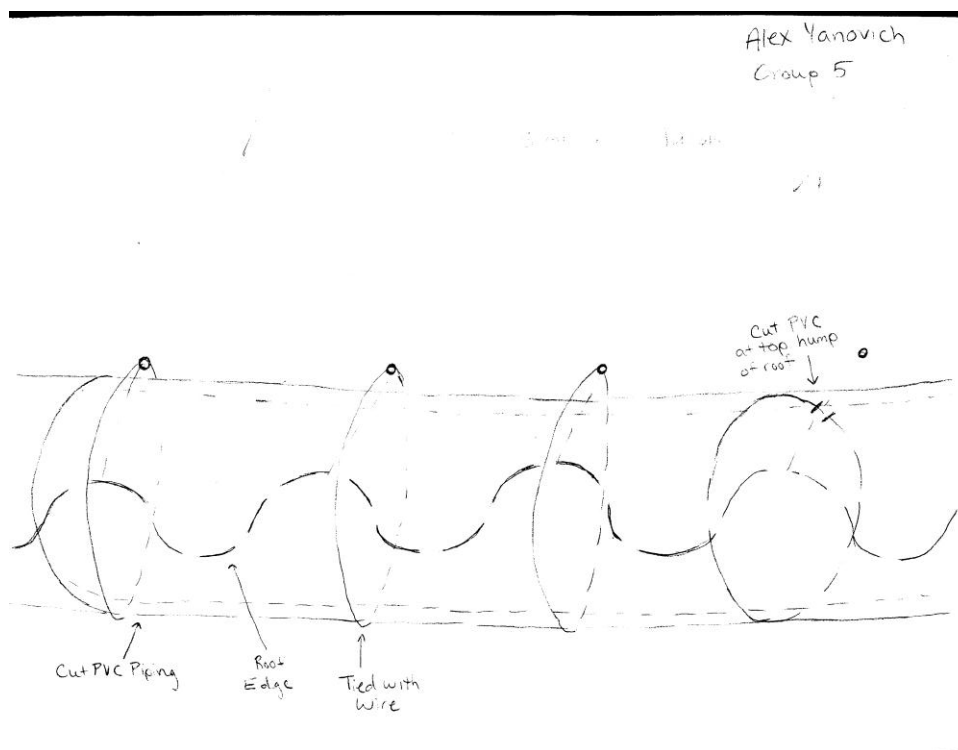
From this analysis of the research done so far, the following sketches were developed by the team:

You may have noticed from the above sketches that two main materials were considered by the group: tin sheets to make the gutters and PVC piping. When the final Prototype design was discussed, the group came to the conclusion that the simpler the design would produce a better gutter. Therefore, PVC piping was the final material decided upon for Prototype #1, because it did not involve any complex metal work.

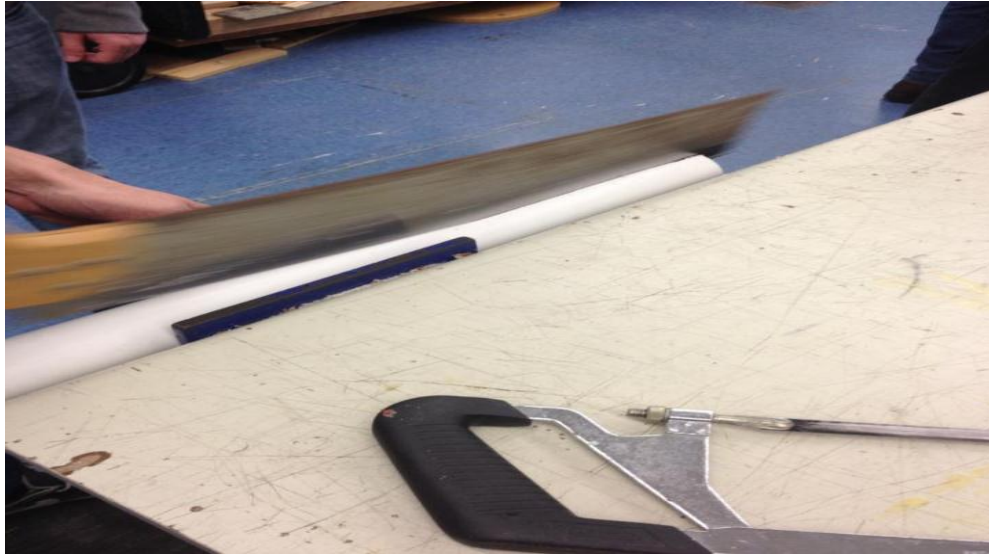
After choosing to use a simple pvc pipe for our gutter design, we determined that cutting out a thin section and attaching it to the roof would be the simplest and most effective gutter design.

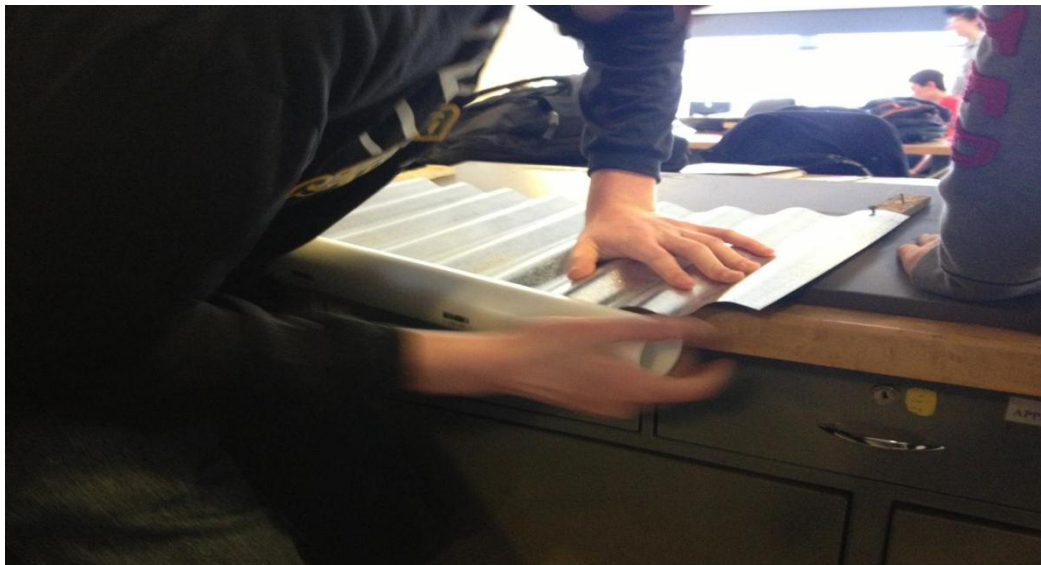
Here we are weaving the pvc piping through the corrugated roofing for a firm attachment to the roof. Using a hand saw made the attachment slightly more difficult to attach but a clean cut with power tools would make the attachment easy and timely.

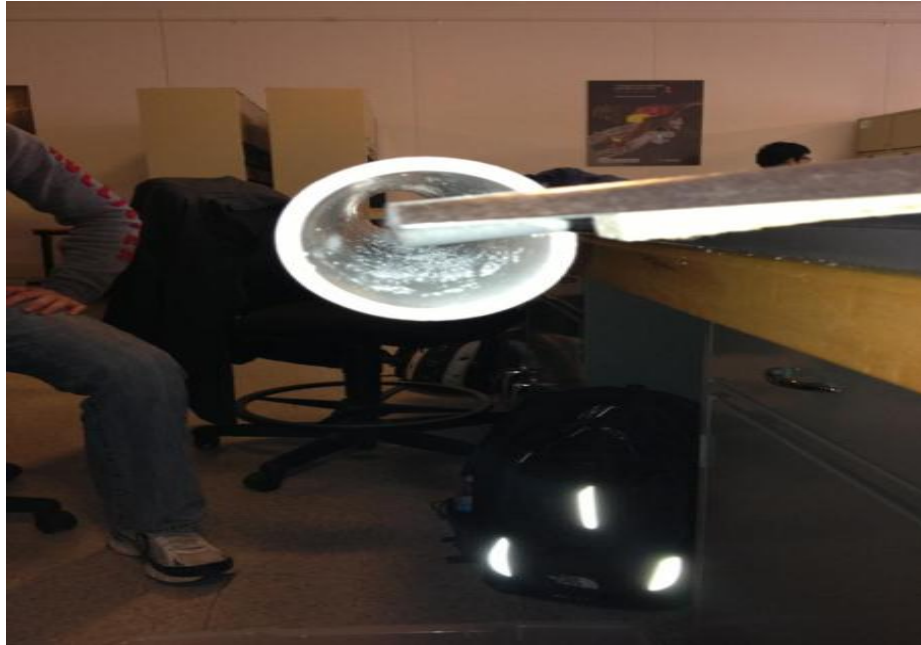
Here is a close up of the pvc attached to the gutter ready for testing. Naturally wanting to form a ring, the pvc pipe has a firm grip on the roof and water can easily fit between the corrugations to be redirected.

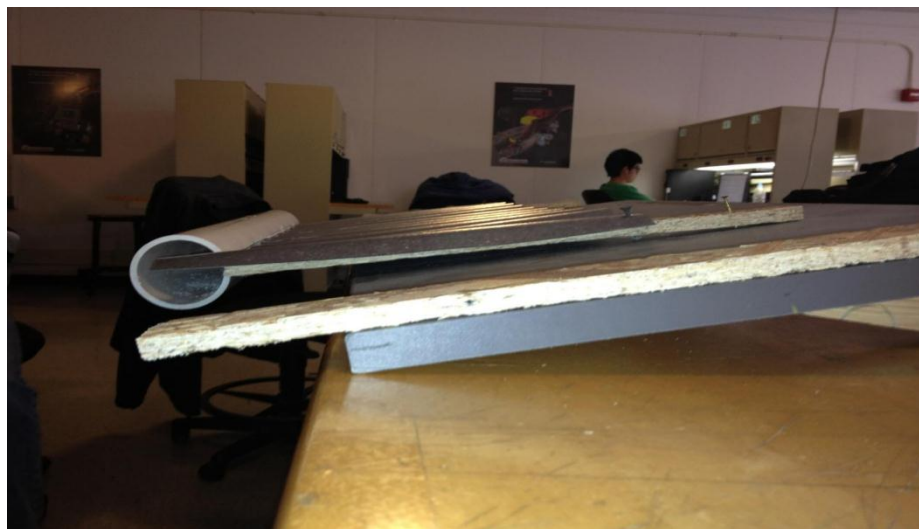
This is the inclined prototype #1 design that we ended up with from the side view. As you can see, part of our design was having an adjustable roof so we could test water flows at different angles.

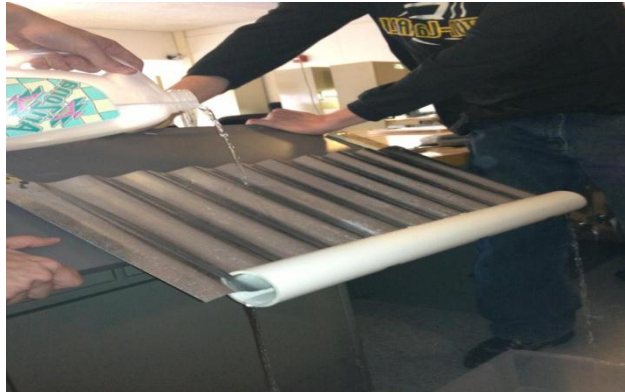
This is a picture of our group testing the gutter in Prototype #1

Prototype #1 testing resulted in a lot of information and brought with it newer ideas and designs that could possibly make our gutter more efficient and/or cost effective. Once our design was built, we took gallon jugs and started pouring water at a rate of  $\frac{1}{4}$  gallon of water per test, to determine if the gutter worked at all. Our tests resulted in a working gutter that effectively redirected rainfall in a new path along the roof section that we built. As you can see in the picture above, the water is entirely redirected to the sides of the gutter and falls out downward at a steady rate. We also tested the waterfall at different roof angles to see if the water would still follow the original path from the first few runs. Only when the angle was very steep (approximately 60 degrees to the horizontal) did any run over the top of the pvc piping. Later, we determined that it was mostly because the rate of water we were pouring was way more than the average rainfall in Kenya over that tests time period.

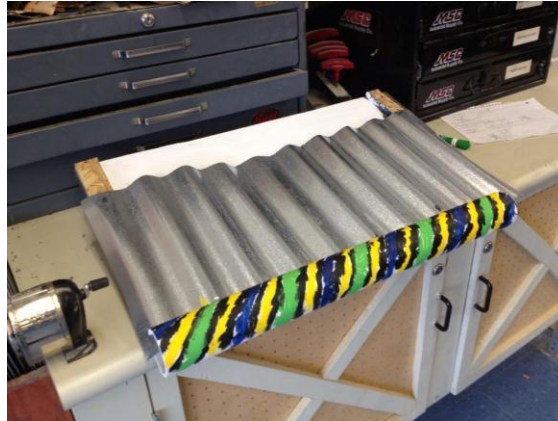
This is a picture of our final gutter Design after Prototype #2

We used the AHP to determine that there were two main things that were wrong with our prototype #1. The first thing that was wrong with our first prototype was the overall cost. The piping we were using was more expensive than a smaller diameter pipe that we could possible use instead. In the end moving to a smaller diameter piping would require much longer construction times, because we could not cut the smaller diameter pipe with the basic tools we had.

The second problem with our first prototype was the degradation of PVC in UV lighting. To fix the UV lighting we decided that painting it with generic paints would add a small cost to the overall construction while greatly adding to the life of the piping as well as the visual appeal. The paint on the PVC piping was a big success. It did not cause any change in how well the gutter collected the water but it did add a great visual appeal that most people would comment on when they walked past.

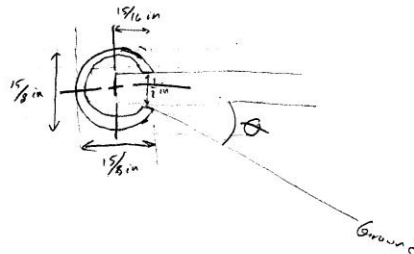
Here is a hand sketch of our final dimensions for the pipe on our gutter system. This does not include the paint, simply the final structural design of our gutter system.

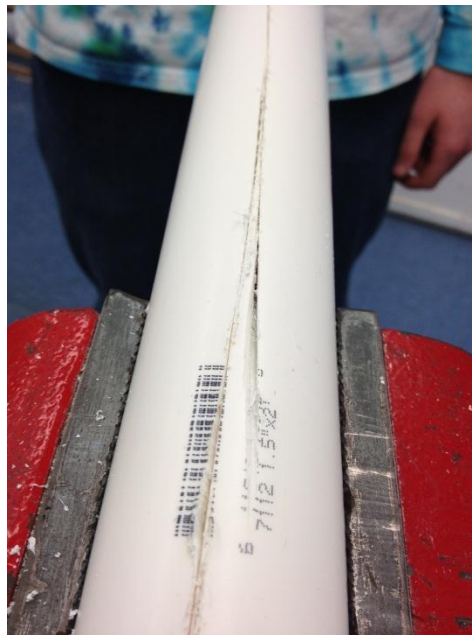
When we attempted to use a smaller sized pvc pipe to save on some of the costs, we found that it was a lot more difficult to cut and decided to stay with our original 2 inch pipe.

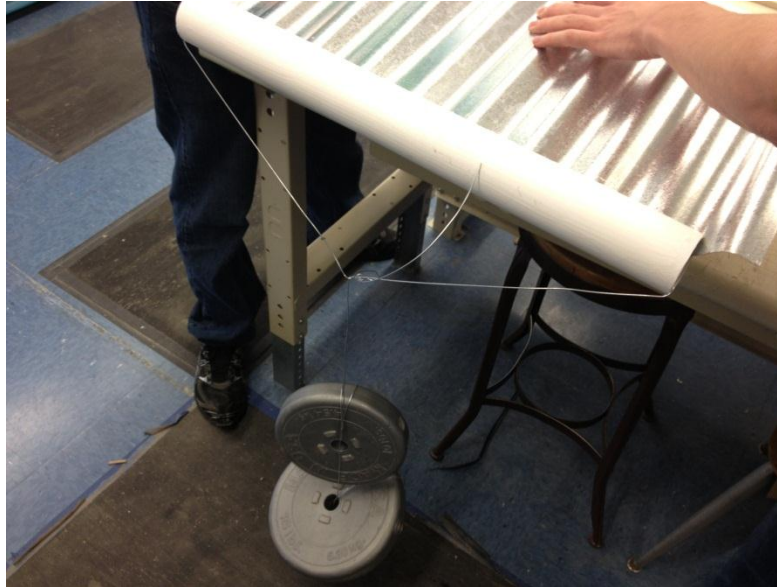
To test durability of our final design we decided to hang some weights from the gutter and manipulate the angles of the roof. No matter what angle we chose, the pvc pipe still hung on strong and was not altered at all. This is one of the major successes of our final design.

Before we attempted anymore improvements on our design at this point we decided to test how securely the pipe was attached to the roof. We did this by running wire through the pipe and attaching that wire to weights, then suspending the roof so that the only thing supporting the weights off of the ground was the pipe itself. We preformed this test with 25 pounds and no movement or instability was observed with regards to the gutter system. At this point the tin roof itself began to bend. With this information we concluded that no further attachment or modification would be necessary to hold the pipe to the roof, since the roof itself began to bend before the pipe showed any sign of becoming detached.

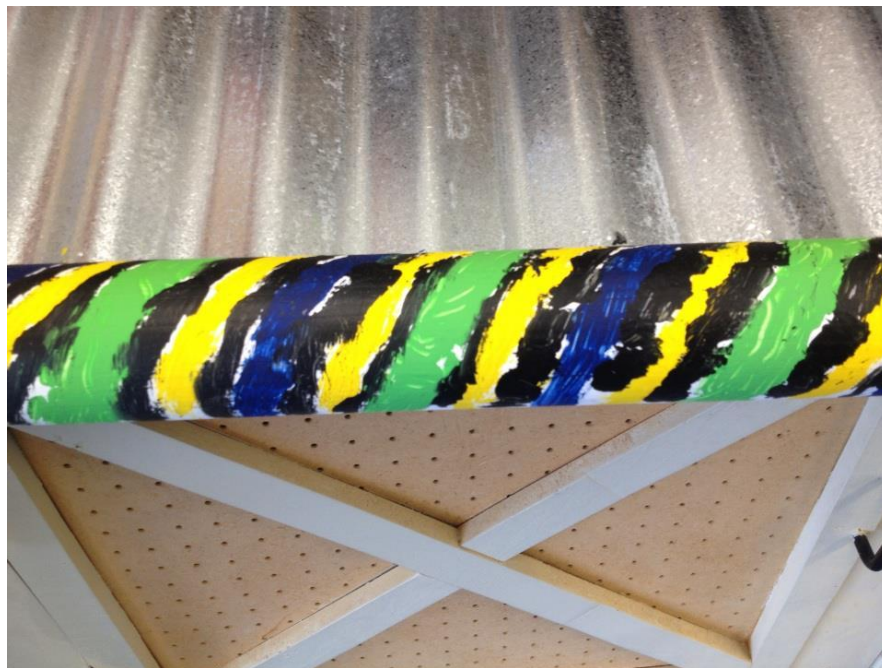
This is our final gutter design after painting. A second major success to our gutter system is the ability to personalize it and make Kenyan houses look colorful and welcoming while still redirecting water during a rainfall.
