The DRYOMATIC 5000

Team 5, Brittany Schraeder, Andre Lopez, Jared Anapolle, and Rashid Al-Najdi

Prototype #1 Testing Summary

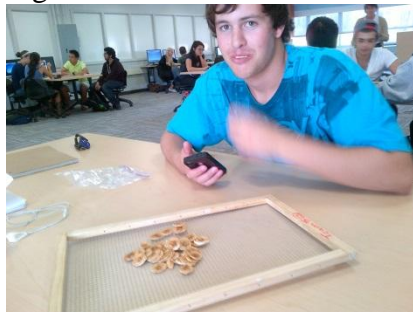
Figure one: the bananas dried on the tray.

The bananas were dried by placing them in an oven for six hours, in this method of drying, the bananas were completely dried (figure 1). Five tests were performed to test the overall quality of the tray, these include; the damp cloth test, durability test, capacity test, a test to determine how easy it was to manufacture, and a cost break down to determine the price. The detailed results of these tests are shown in table one.

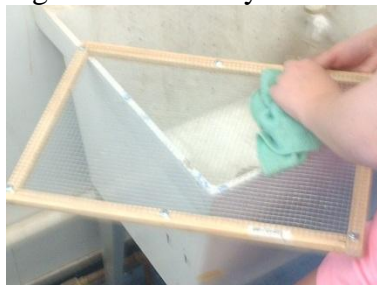
Figure two: the tray was able to be washed with just a damp wash cloth (washing test) .

Test	Description of Test	Results / Observations
Damp Cloth Cleaning Test (3rd test ran) Test performed on October 3rd around 2:20 in the wood shop.	Washed the tray for ten seconds with only a damp wash cloth to see how easily the tray could be cleaned.	The tray was not very dirty to start out with and when cleaned, the remaining banana came off very easily and very quickly without much effort. This test can be seen in figures two, three, and four.
Durability (Last test performed) Test performed on October 3rd around 2:30 in the wood shop.	The tray was dropped from various heights of one foot, two feet, and three feet to see if the structure of the tray was sound.	The tray held up well for the most part, while dropping it, one of the corners of the tray broke. The cause of this breakage was due to the fact that the nail was not nailed in properly.
Capacity Test (2nd test ran) Test performed on Saturday	The tray was filled bananas to see how many slices of bananas could be effectively dried.	The tray held a total of 55 banana slices on the half size, with a full size capacity of 110, however for the final product a tray with more capacity would be optimal.

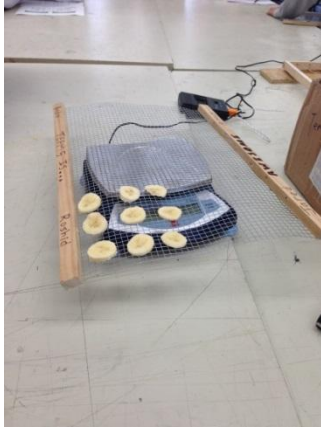
Figure five: Weighing the bananas on the tray.

The method of drying this time was by using a hair dryer and placing it on the bananas for 15 minutes, the temperature varied between 54°C - 68°C during the test (figure 5 and 6). The bananas were dried around the edges, however the middles were still moist (figure 7). This is not surprising though since they only had 15 minutes to dry. Seven tests were performed to test the overall quality of the tray, these include; the damp cloth test, durability test, capacity test, a test to determine how easy it was to manufacture, a flexibility test, a cost break down to determine the price, and research to determine if the product was made of only food grade materials. The detailed results of these tests are shown in table two.

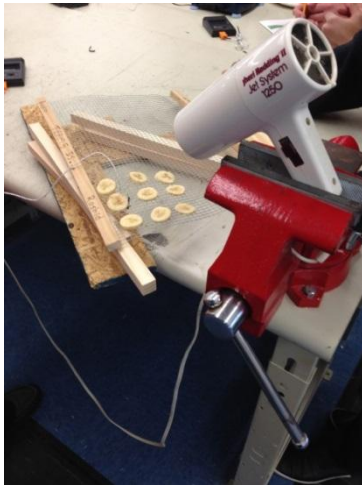
Figure six: Drying the bananas.

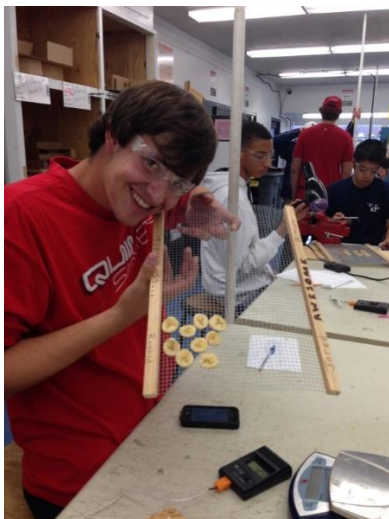
Figure seven: The dried bananas, displayed by Jared A.

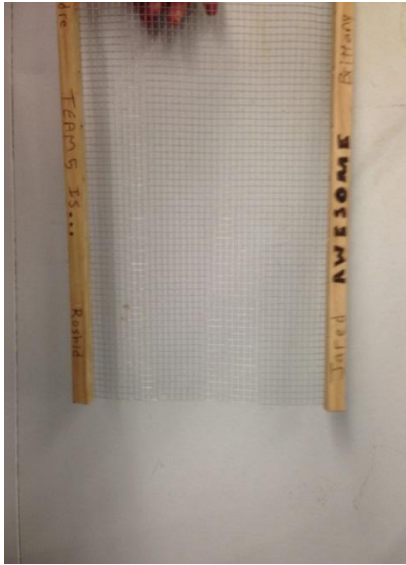
Figure eight: After the bananas were dried, they came off the mesh very easily.

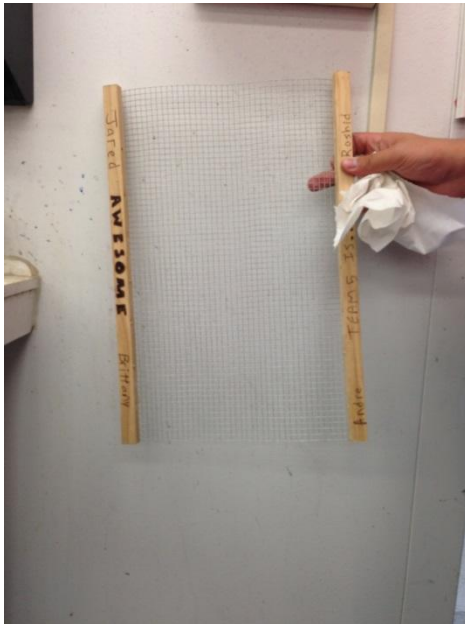
Figure nine: After cleaning the tray, which took very little effort to do.

Test	Description of Test	Results / Observations
Damp Cloth Cleaning Test (Last test performed) Test performed on October 10th around 2:40 in the wood shop.	Washed the tray with only a damp wash cloth for ten seconds to see how easily the tray could be cleaned.	The tray was not very dirty to start out with and when cleaned, the remaining banana came off very easily and very quickly without much effort (figure 8 and 9).
Durability (3rd test ran) Test performed on October 10th around 1:40 in the classroom.	The tray was dropped from various heights of one foot, two feet, and three feet to see if the structure of the tray was sound.	The tray held up well, it was dropped numerous times without any part of the tray breaking even a little bit. This is a large improvement from the first prototype.
