EDSGN 100
Section 20, Spring 2013
Liz Kisenwether

I³ Greenhouse Glazing

Katie Raudenbush, Max Webb, Lauren Thompson, Darren Slotnick

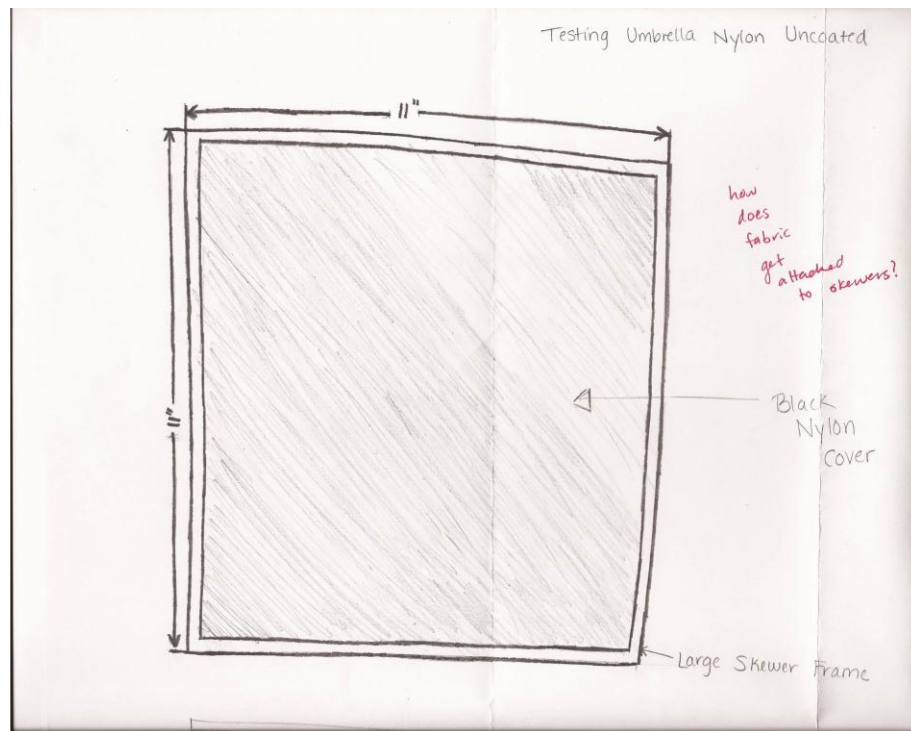
Figure 1: Shown above is a scanned version of an early concept design for a frame made from wooden skewers that can be used to hold a material being tested.

Figure 1 shows a scanned photo of our earliest design concept. Figures 2 and 3 below show our first four prototypes, and the structure they were held together with. We tested these prototypes to see if they had the features that our glazing needed. Figure 4 shows the first paint coating we tested, hoping that it would help our materials become more durable and water-resistant. Finally, Figure 5 shows the coated nylon material being put through a test to see if its coating would flake off if the material was stressed or folded.

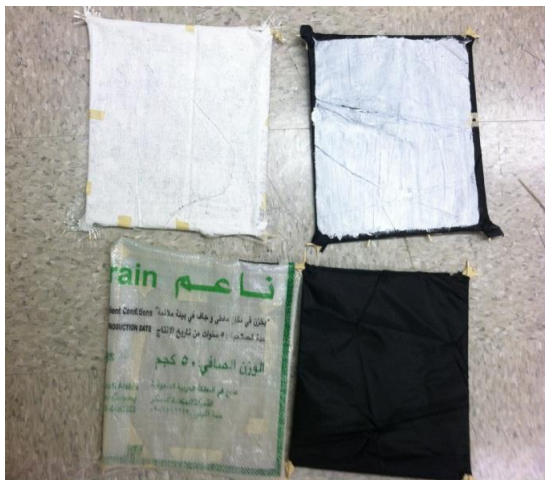
Figure 2: This photo shows our first four prototypes. Coated and uncoated rice bags are displayed on the right, and coated and uncoated nylon is displayed on the right.

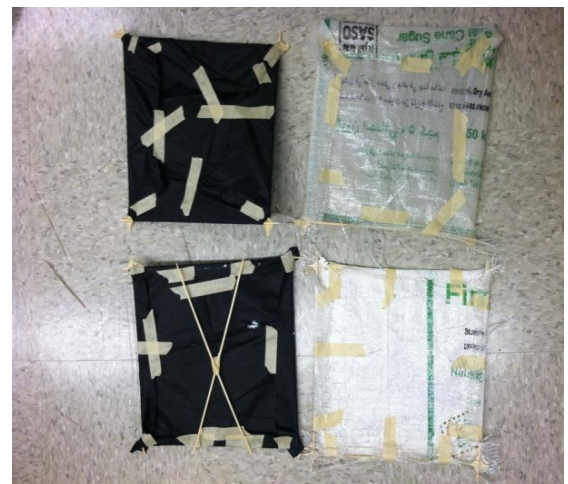
Figure 3: In this photo, the backs of our first four prototypes are displayed. You can see the skewer frames that hold the material taut.

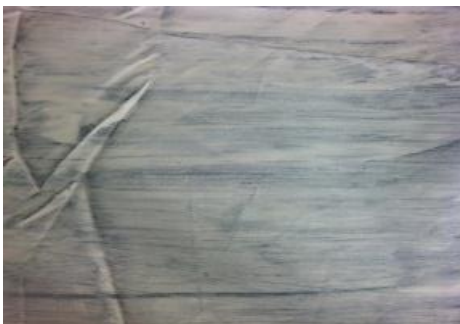
Figure 4: Shown is a close-up of the BEHR paint coating on the nylon fabric.

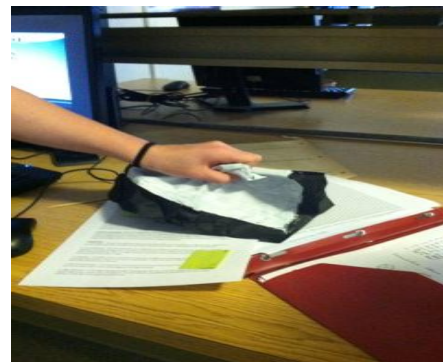
Figure 5: This photo demonstrates the lack of stiffness of the coated nylon material.

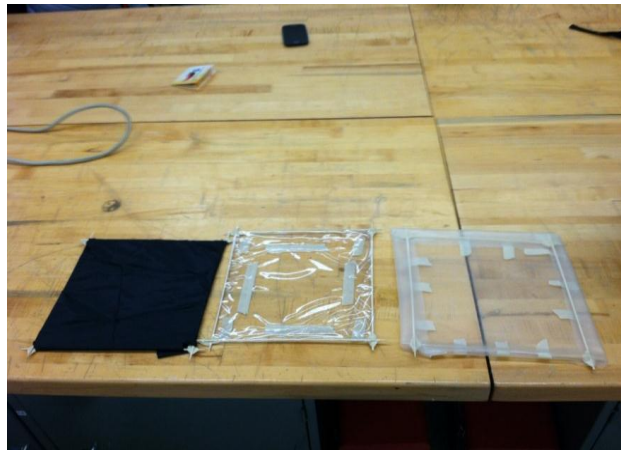
Figure 7: This photo shows our three final prototypes: nylon, PVC plastic, and shower curtain.

matrix and selection matrices. As a result, we decided to stop testing the rice bags and focus our efforts on two new materials for prototype 2, specifically Polyvinyl chloride plastic, also known as PVC plastic, and shower curtain. These prototypes are shown in Figure 7 below: nylon is the black square on the right, PVC is the clear plastic square in the center, and the shower curtain is the hazy square to the right.
