Tray de Soleil Final Results

Tray de Soleil was the final prototype we designed as a group in the search of a tray design that would be light in weight, easy to clean, food grade, durable (to last a minimum of three years) and affordable at a cost under \$10. After building our second prototype we carried out different tests to assess its effectiveness in meeting our desired features.

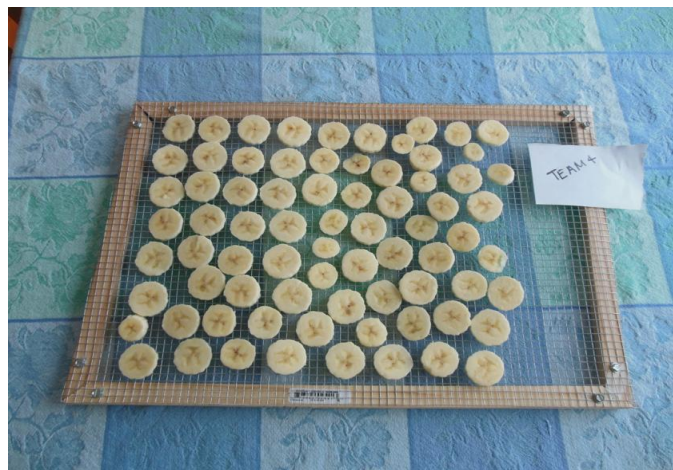
The capacity for the second prototype decreased by seven slices due to the addition of the wooden piece in the center, yet it was not a significant amount. With careful placement, this loss of capacity can be made up for. The tray continued to exceed our expectations for capacity as it currently fits 84 banana slices (1/4 thick). In reality, the dimensions of the tray will be bigger than our second prototype, thus increasing the capacity significantly.

Figure 2: Prototype #1 Demonstrating Capacity

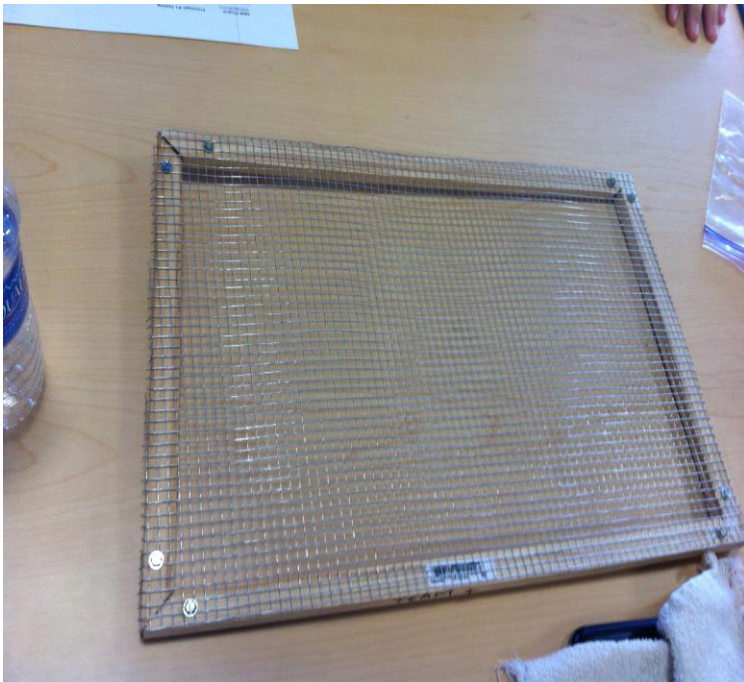
Improvements were made to make the tray more durable since the first prototype failed the durability test. The frame was redesigned and the corners were altered from being angled to rectangular joints. Additionally, a wooden bar was placed in the center of the tray for additional support. Four more screws were also added to support the wire mesh and make it more stable. It was very important for our team to meet this feature, as we understand that this is an investment and should

Figure 3. Prototype #1 Weak Frame

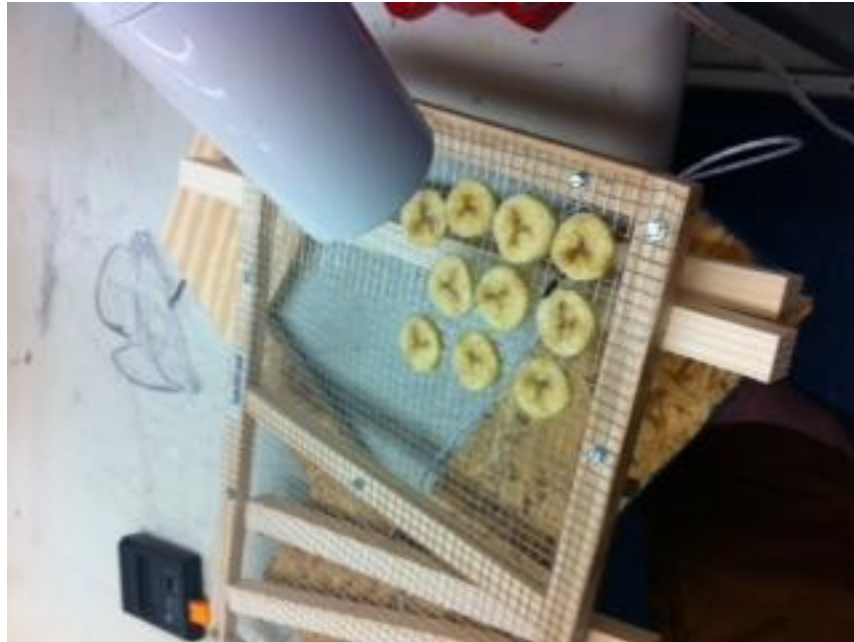
After drying the banana slices all remained intact and none broke. The tray was effective in drying the banana slices and in fact 8.5g of water evaporated in 15 minutes of drying with a hair dryer, which is considered a complete cycle.

Figure 5: Prototype #2 (being dried by a hairdryer)
